Application Note 1034

Multi-zone Branch Box Applications with Blue Diamond Pump

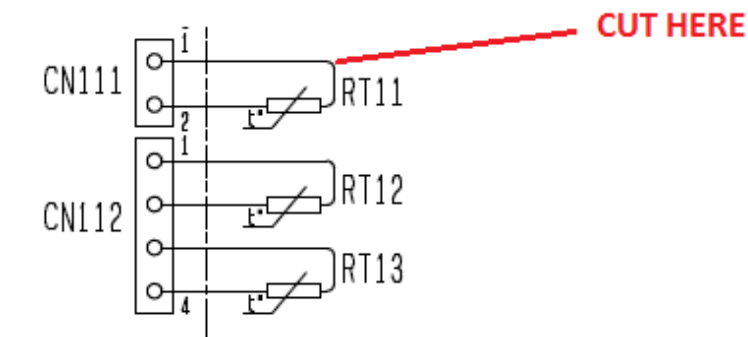
Communication errors and or 71** error codes reported at equipment or controller.

Blue Diamond pumps use a heated thermistor to monitor for high water level. In order for the NC (normally closed) safety contacts to close the thermistor needs to heat up. It can take up to 2 minutes to heat to the proper temperature and then close the contacts.

Wire the NC safety circuit from the pump in series with one of the indoor thermistors. Best practice is to solder the connection, or use butt splice connector.

****FOR APPLICATIONS USING THE APPLICABLE MODELS, DO NOT BREAK THE S1, S2 or S3 WIRE TO THE INDOOR UNIT OR ERROR WILL OCCUR****
